## **The Gibson Farm**

**Prepared by Maura H. Overland and  
Christian W. Overland  
December 16, 1997**

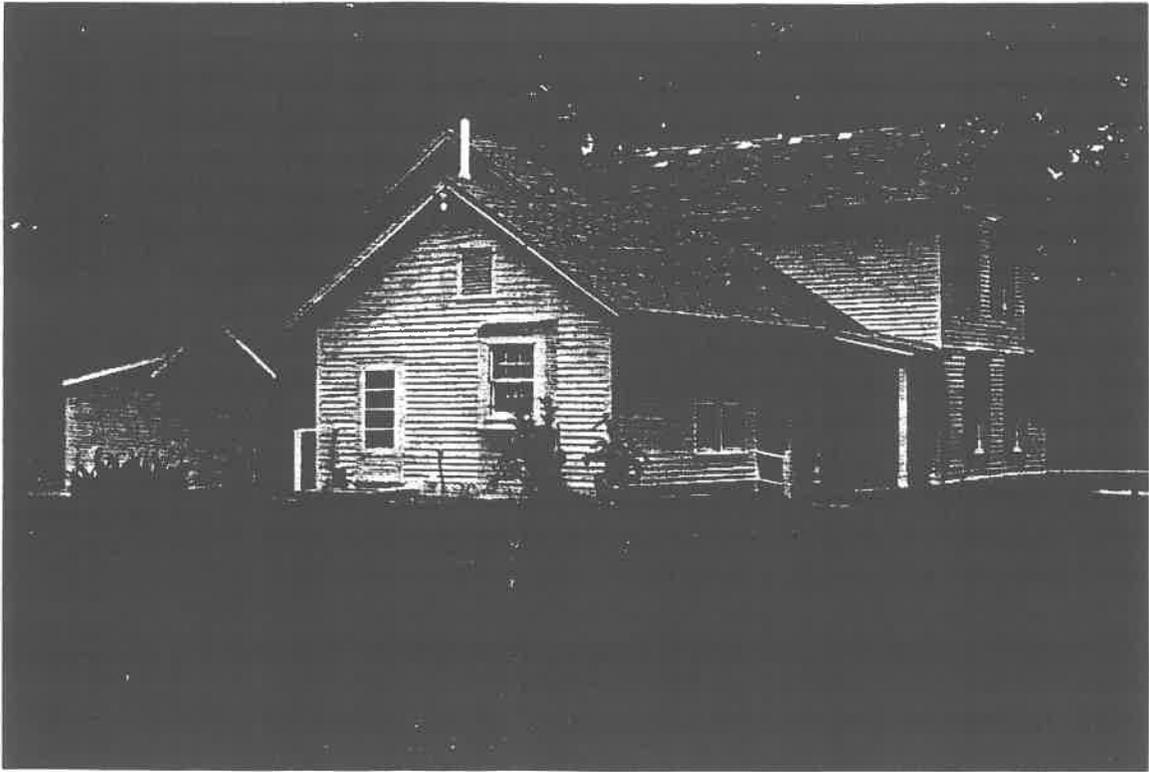
Figure 17 - Milk House, on right, 1997

Unknown date of construction. most likely dates to James Gibson's stewardship of the farm 1890-1943. The original stone foundation was repaired with modern concrete and a lean-to tool shed was added to the side when the house was remodeled in the 1960s (See Figure 17).

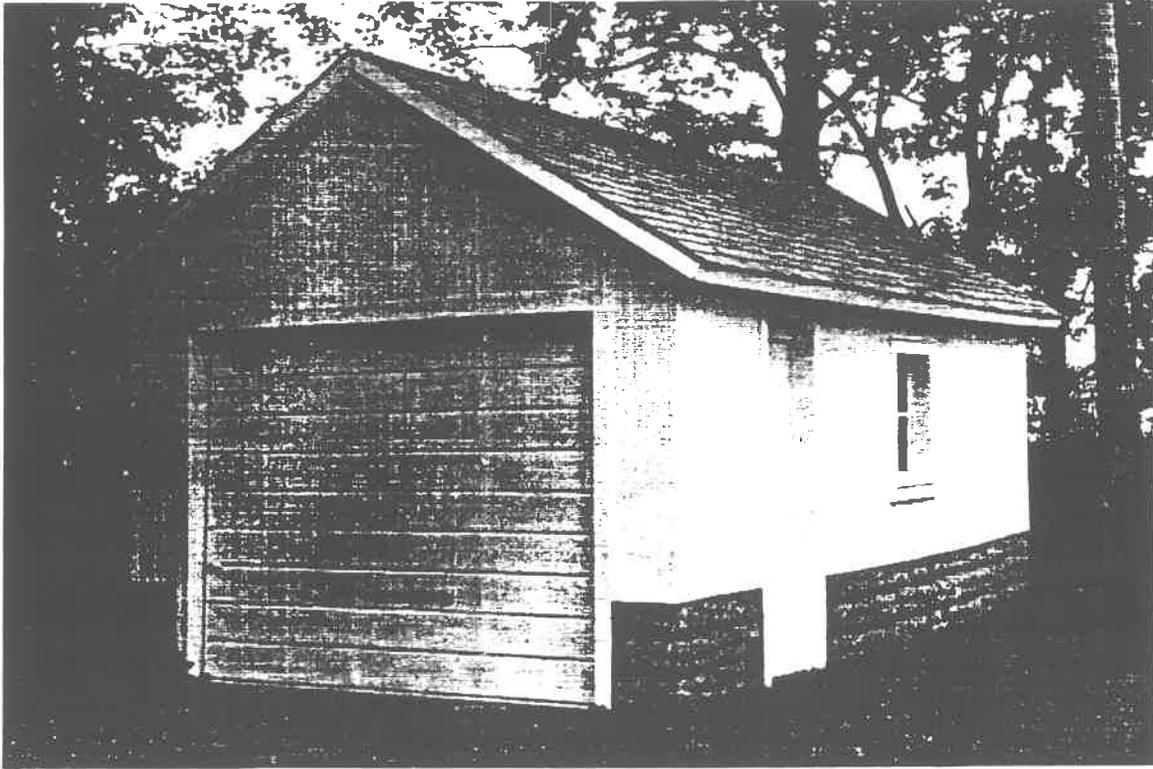
Figure 18 - Garage, 1997

foundation of this building are typical of inexpensive/commercial structures built in the 1920s and 1930s. The modern metal garage door with opener was added by Mildred Gibson as part of the 1965 renovations of the farmhouse (See Figure 18).

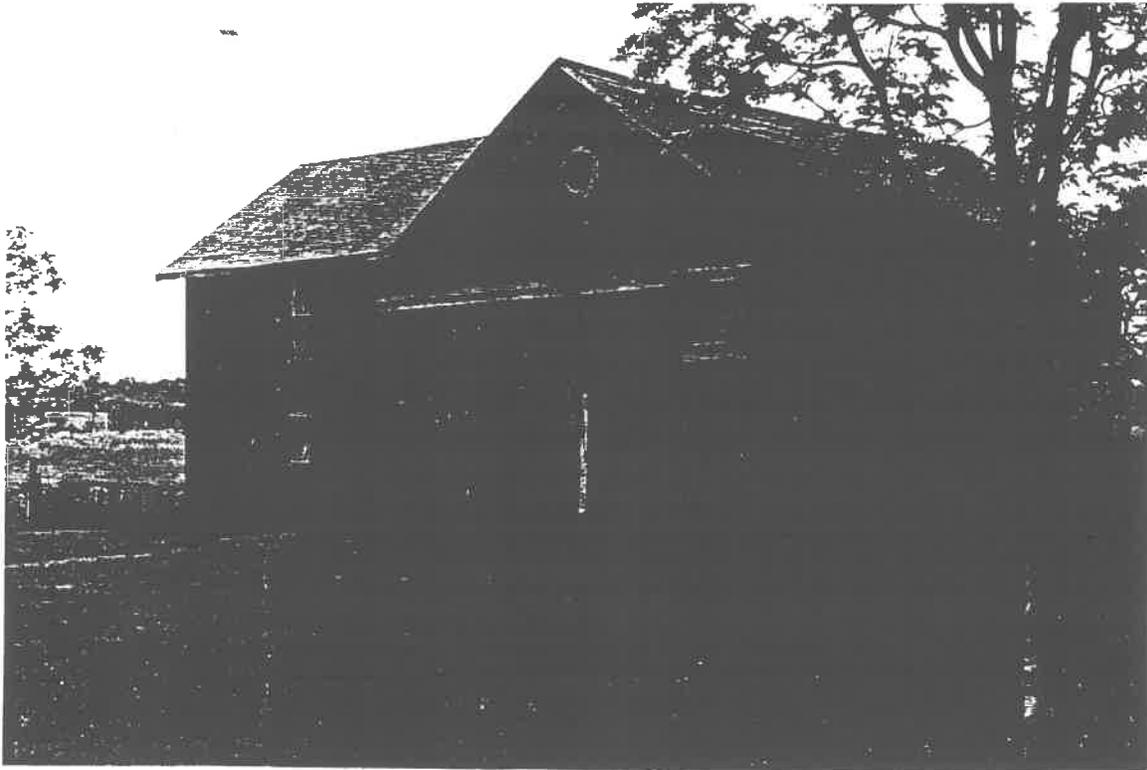
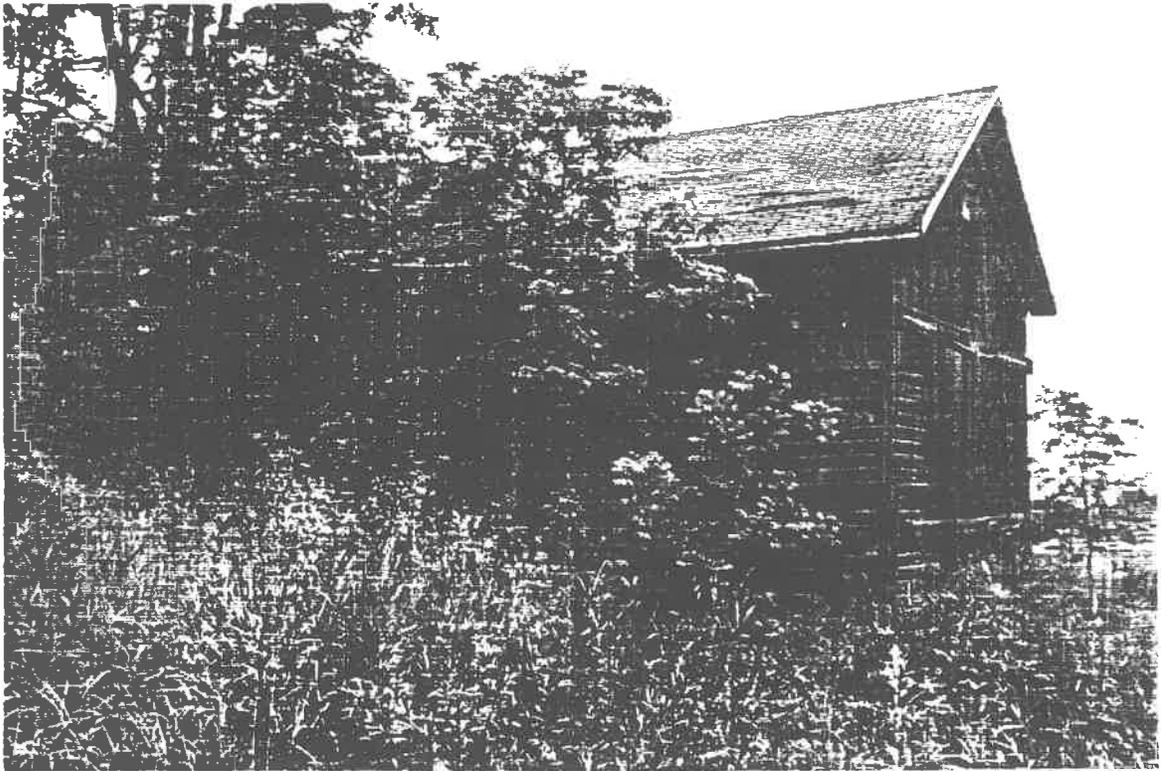
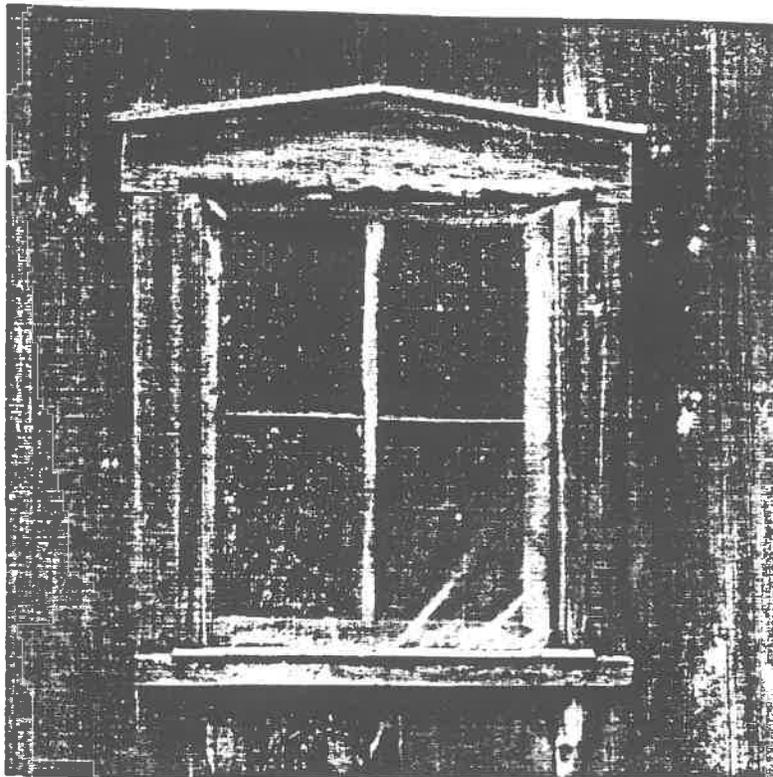
The existing two-story red board and batten barn, 48x42x20 (1872), was most likely constructed at the same time as the house ca. 1871. The use of smaller timbers and balloon framing indicates that this structure was most likely built after 1865 and the board and batten siding would indicate an 1860s or 1870s date. The barn has modern concrete footings over the original stone foundation and it is leaning badly to the left. The asphalt shingle roof is a modern replacement. Both Matthew Gibson and James Gibson's initials are painted in white in the loft area of the barn and James Gibson's name is inscribed on one of the sliding doors and inside the barn on the stairway wall. This barn was used as a pig pen in the 1940s and also housed a corn crib. The remainder of the space was most likely used to store carriages and farm equipment. The horse barn is a timber frame structure with a board and batten rough lumber exterior and a wood shingle roof. There are four four-over-four sash windows and one round gable window with four quartered lights. The barn in the north south gable portion was a carriage area that included a tack room and corn crib. Artifacts found in this area included James Gibson's racing sulky #30 and a sledge, #42, & #78, used for hauling wood from the wood lot at the southern end of the farm.<sup>32</sup> The stall area was used for horses then pigs in the 1940s (See Figure 19 a-d).<sup>33</sup>

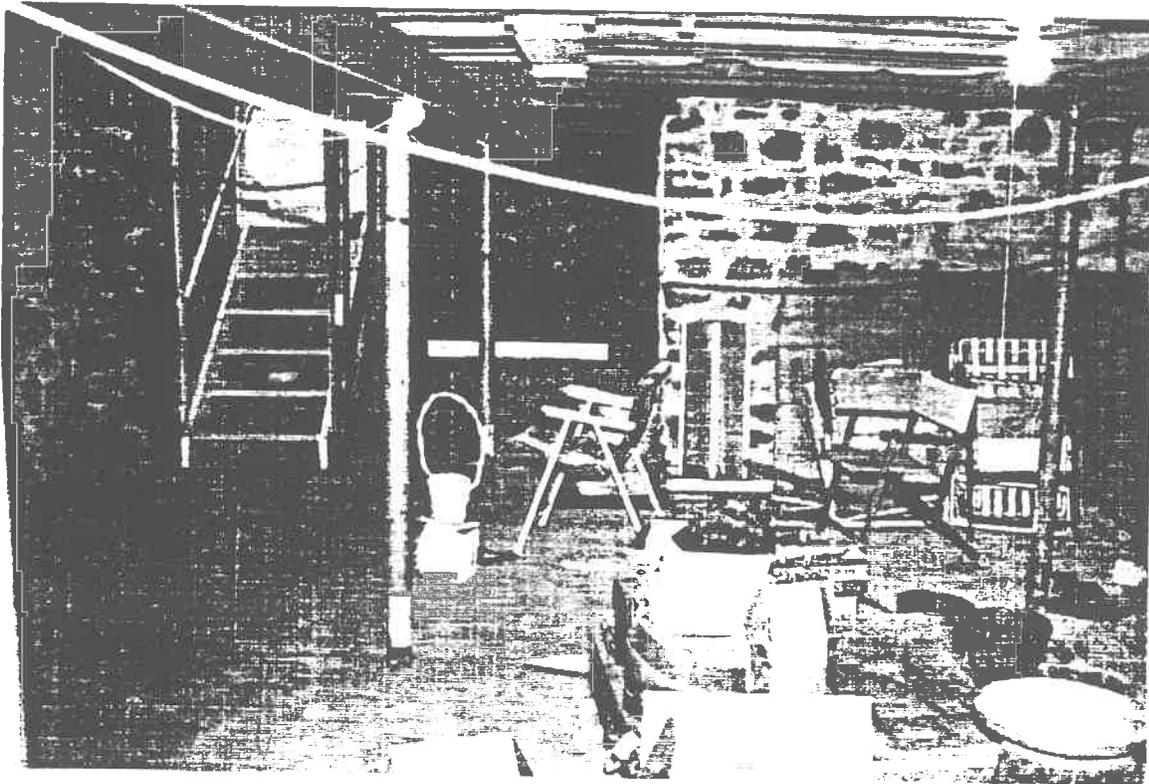
Figure 20 - Interior, Basement, West View

The current basement stairway was not part of the original house. Originally the basement did not have an interior entrance nor an interior stairwell. In the early twentieth-century a stairway was added and updated in the 1965 renovation. Evidence that supports that there was not an interior stairwell includes; lack of space between any joists that is larger than 24" in width, current stairwell used to have joists passing through the area (see mortises in timber above the bottom of the stairwell and cut joists resting on steel I-beam behind stairwell), removal of stone foundation wall and door (#879)<sup>43</sup> which was replaced by a steel I-beam in 1965. Therefore, the side walls and the entire stairwell are part of the 1965 renovation. (See Figure 20)
