# ROAD SAFETY AUDIT

**DOWNTOWN WIXOM**  
OAKLAND COUNTY, MICHIGAN

**Cincar Consulting Group, LLC**  
17199 N. Laurel Park Drive  
Suite 204  
Livonia, MI 48152

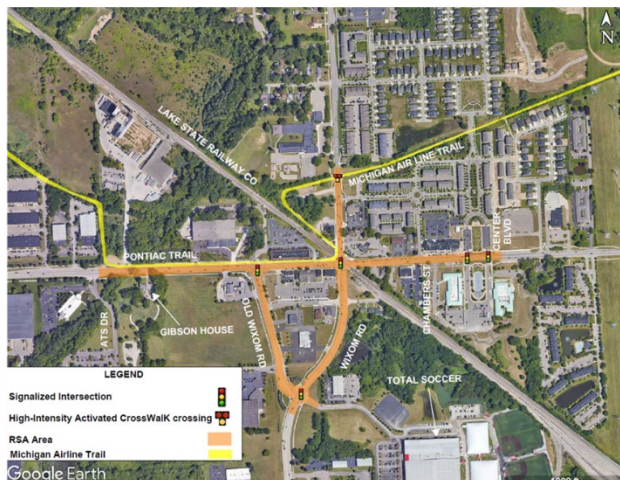
**Figure 2: Wixom RSA Limits**

The objective of the study was to review safety within the downtown core of the City of Wixom centered around the signalized intersections of Wixom Road and Pontiac Trail, and the recently completed Michigan Air Line Trail. The project limits include Wixom Road from Old Wixom Road to Michigan Air Line Trail crossing (21,921 AADT), Pontiac Trail from ATS Drive to Center Boulevard (8,677 AADT), and Old Wixom Road from Pontiac Trail to Wixom Road. The opening of the Michigan Air Line Trail has increased the amount of vulnerable roadway users. The Lake State Railway goes through the intersection located at Pontiac Trail and Wixom Road. The project limits are shown in **Figure 2**.

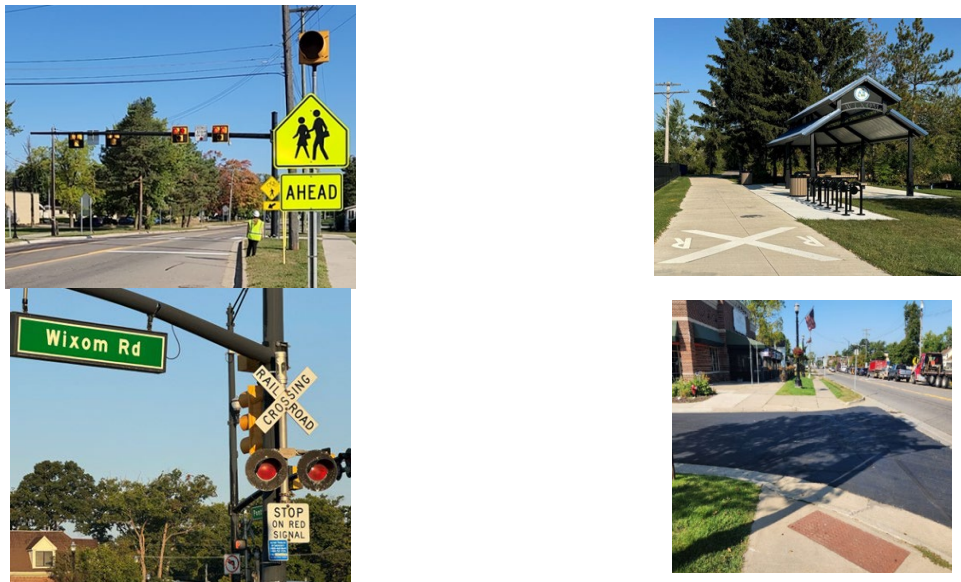
**Figure 3: Roadway Characteristics**

Roadway characteristics (**Figure 3**) such as road geometry, signage, and more are illustrated in depth.

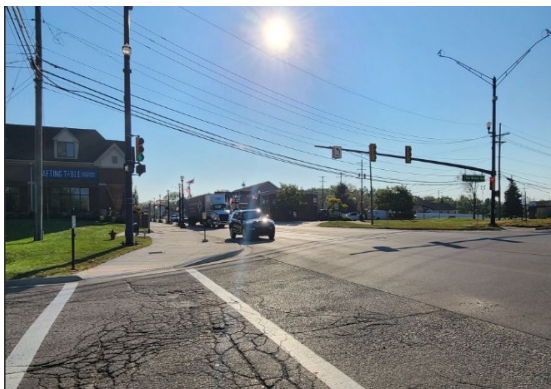
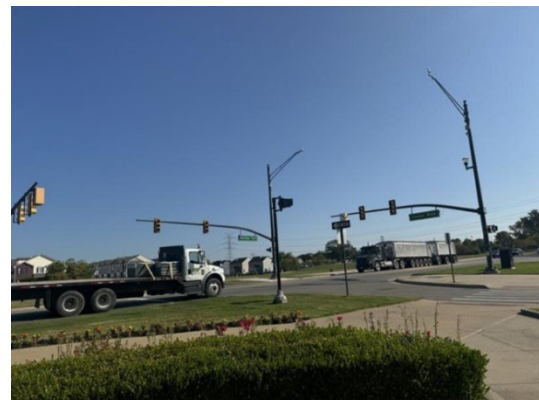
**Figure 4: Example of Roadway Users**

The primary modes of travel throughout the corridor consist of passenger vehicles, trucks, and vulnerable road users (VRU) such as bicyclists and pedestrians. Heavy vehicle traffic is high throughout the study area. The addition of the Michigan Air Line Trail has led to an influx of VRU’s throughout the study area. Between the three segments, the study area AADT ranges from 8,677 to 21,921. **Figure 4** shows an example of roadway users.

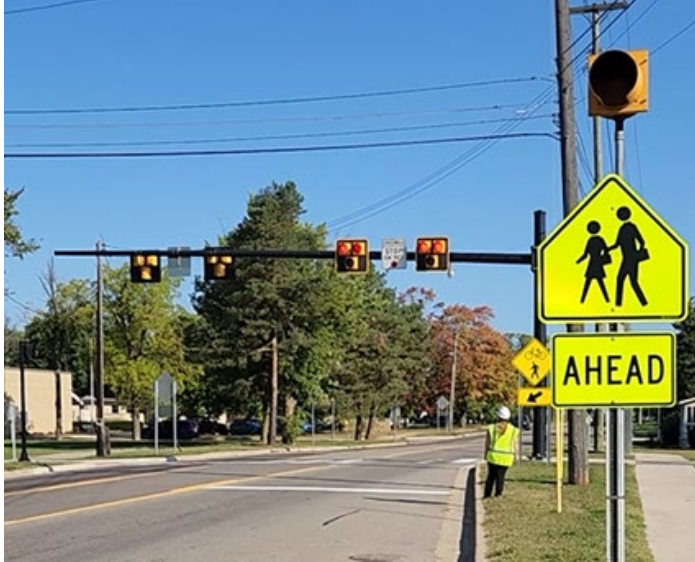
**Figure 5: HAWK Signal Along Wixom Road**

A HAWK signal is a traffic control device that stops road traffic and allows pedestrians to cross safely either on foot or bike. The HAWK signal is located along Wixom Road 170 ft north of Johanna Ware that allows pedestrians on the Michigan Air Line Trail to cross east/west (**Figure 5**). Concerns regarding the Hawk signal include improper usage by both vehicles and pedestrians, and poor sight lines to the west of the crossing. During field review, the RSA team observed vehicles disregarding the HAWK signal on red once the pedestrian was outside of the roadway. This is concerning behavior as the HAWK signal still displays a walk signal and bikers traveling at a rapid speed may assume it is safe to cross. The project team was also made aware that bicyclists sometimes use the crossing without activating the signal. In order to combat this, the City of Wixom currently has a sign featuring a tutorial for the signal along each side of the crossing. Another area of concern is the sightline to the west of the crossing. Vegetation conceal pathway users from SB traffic on Wixom Road as they approach the HAWK signal.

- **Maintenance of HAWK Clear Zone:** Clear zone improvements such as removal of vegetation will increase sight distance and will provide driver’s greater sight lines of oncoming trail users.

- **HAWK Education:** Educate the public on HAWK signal operations through social media or public events.
- **Widen and Repair Sidewalks:** Widen sidewalks on Pontiac Trail between Wixom Road and Center Boulevard, and repair sidewalks where needed.

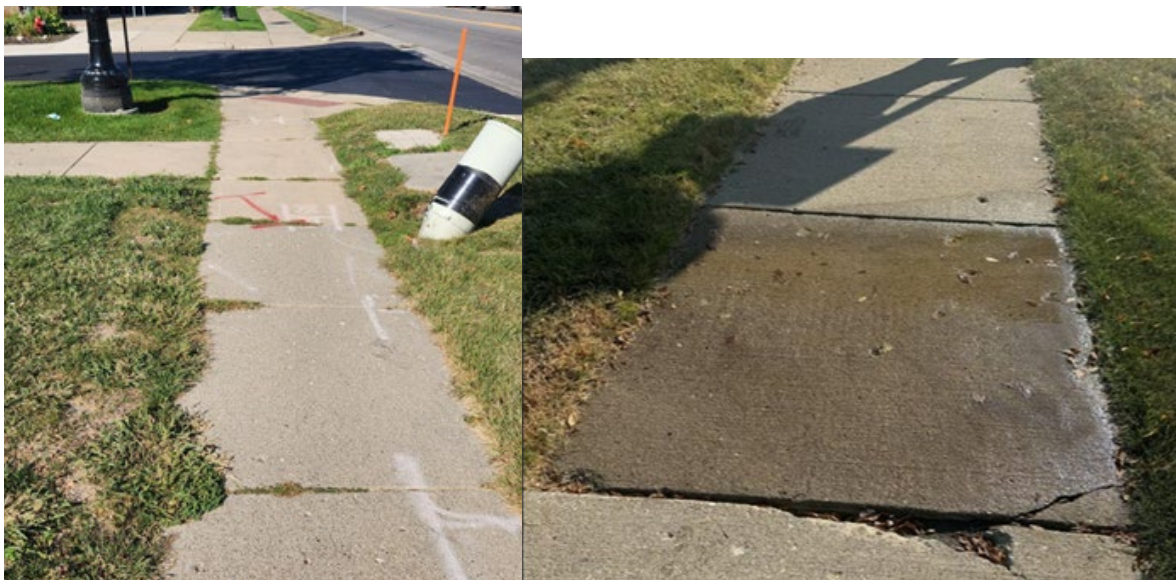
**Figure 6: Sidewalk width and condition**

The RSA team also noted that sidewalk width and condition were concerning along parts of the study area. Poor sidewalk conditions were noted from the south most point of the study area along Wixom Road and Old Wixom Road to Pontiac Trail. The sidewalk width was measured as approximately 4 ft from along the northeast corner of the Wixom Road and Pontiac Trail Intersection, and continues east along Pontiac Trail to W Chambers Street . The following issues are highlighted in **Figure 6**.

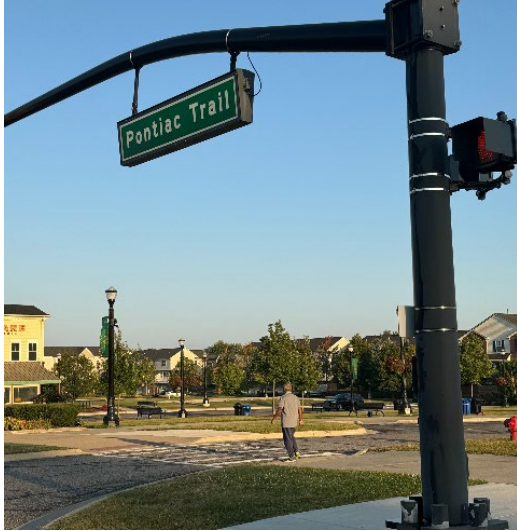
**Figure 7: Pedestrian crossing within crosswalk**

Due to the high amounts of VRU, opportunities for vehicle pedestrian crosswalk conflicts are high (**Figure 7**).

- **Leading Pedestrian Intervals:** Updating signals throughout the study area to have leading pedestrian intervals will allow pedestrians to enter the crosswalk 3-7 seconds before vehicles are given a green indication. This may increase the visibility of crossing pedestrians and enhance safety for pedestrians that may be slower through the intersection.

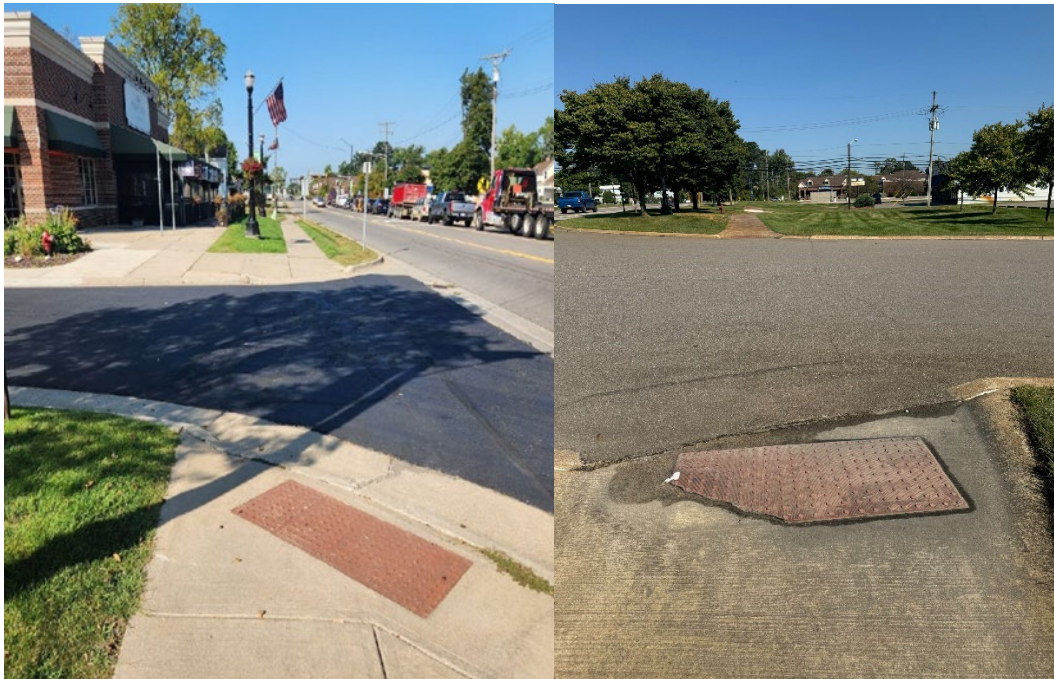
**Figure 8: ADA ramps within the study area**

ADA tactile warning surfaces and ramps are required to alert people with visual impairments to changes in walking surfaces. Throughout the study area ADA tactile warning surfaces and ramps were noted as facing the wrong way, missing, or broken.

- **Standardize ADA ramps:** Confirm all intersections are ADA compliant.
- **Wayfinding:** Add wayfinding to Gibson House and other downtown amenities.

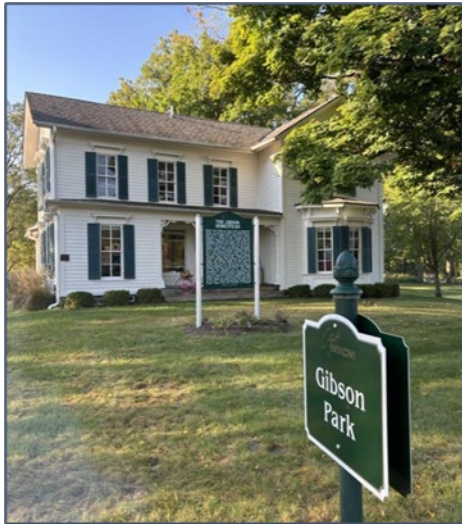
**Figure 9: Gibson House**

During the kickoff meeting, the RSA team members were made aware of concerns surrounding the future and current path of travel of VRU to and from the Gibson House. Gibson House is a historic farmhouse owned by the City that acts as a multipurpose facility that hosts events such as senior citizen and teen activities, a community garden, and

horseshoe pits (**Figure 9**). It is located on the southside of Pontiac Trail at the west end of the study area. Pedestrians heading to Gibson House from the east are required to cross to the south side of Pontiac Trail at Old Wixom Road. The Michigan Air Line Trail is located north across Pontiac Trail from the Gibson House. VRU’s traveling from this direction must cross south at Old Wixom Road. Concerns were raised whether pedestrians will travel from the Air Line Trail to Old Wixom Road or attempt to cross the four lanes of traffic and cross Pontiac Trail outside of a crosswalk.

- **HAWK Signal near Gibson House:** Complete a study to determine if a HAWK would warrant; the addition of a HAWK signal near Gibson House could help VRU cross Pontiac Trail from the Air Line trail to Gibson House.

- **Pedestrian refuge:** The addition of a pedestrian refuge at Gibson house would aid in the visual narrowing of the roadway and allow VRU’s to cross less lanes of traffic at once.

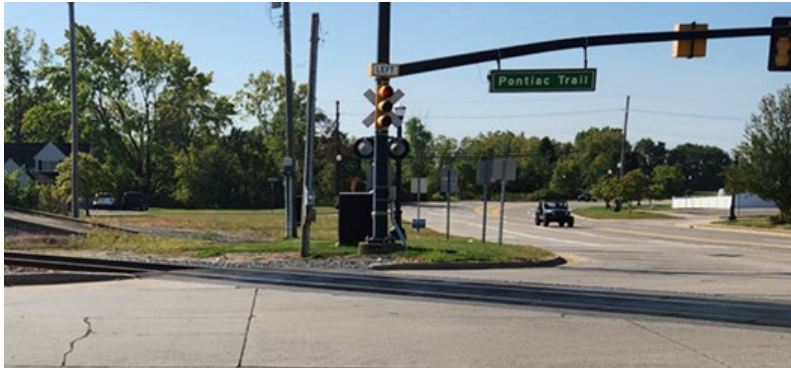
**Figure 10: Lack of physical barriers along railroad tracks**

Physical barriers at railroad tracks such as automatic gates are used to warn drivers and pedestrians of approaching trains. These gates are also helpful in preventing vehicles and pedestrians from entering the crossing while a train is approaching. Currently there are no physical barriers or gates at the intersection for vehicular traffic.

- **Installation of Railroad Gates:** Physical barriers such as railroad gates are used to warn drivers and pedestrians of approaching trains. These gates are also helpful in preventing vehicles and pedestrians from entering the crossing while a train is approaching.
- **Sign Updates:** Updates in railroad signage to newer signs with higher reflectivity to help vehicles and pedestrians navigate the railroad crossing.
- **Leading pedestrian interval:** Signal adjustment that allows pedestrians a 3-7 second head start at signalized intersections before vehicles are given a green light. This can help get pedestrians out into the crosswalk and allow vehicles better sightlines as they enter the intersection.

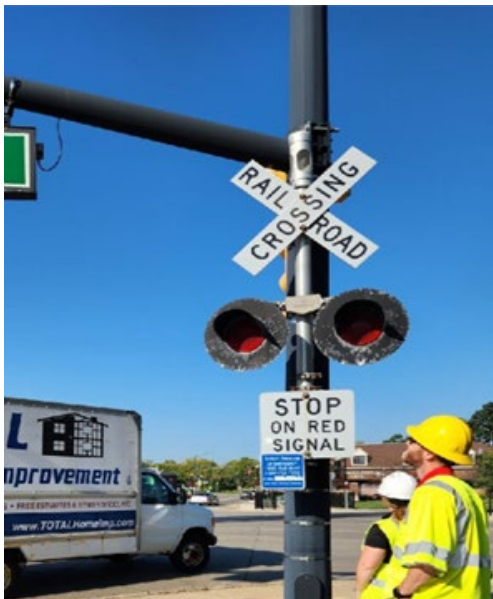
**Figure 11: Railroad Crossing signs**

Existing railway signage has poor visibility as it is located off to the side on the signal or shown through pavement markings on the roadway

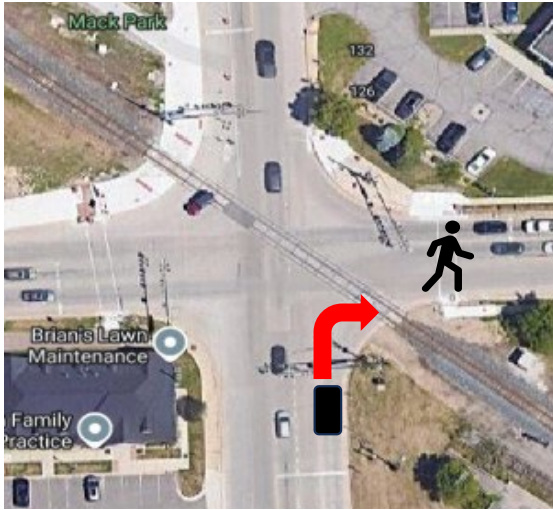
**Figure 12: Location of stop bars at Wixom Road and Pontiac Trail**

Due to the location of the railroad tracks the stop bars located at the Wixom Road and Pontiac Trail intersection are approximately 115 ft from center (**Figure 11**). Due to the placement of the stop bars right turning vehicles heading from Wixom Road to Pontiac Trail

have poor sight distance and may not be able to see pedestrians crossing within the existing crosswalk.

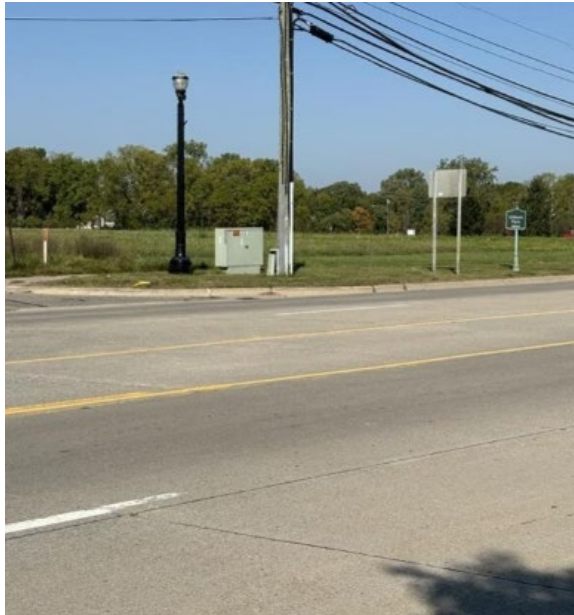
**Figure 13: Wide Roadway Geometry**

Speeding is an issue throughout the study area. This can be accredited to elevated speeds entering the study area as well as the roadway geometry. Speeds along Pontiac Trail to the east and west of the study area are 45 MPH, followed by a short section that is 35 MPH, and 25 MPH within the study area. This elevated speed entering the study area as well as the wide roads can encourage speeding (**Figure 12**).

- **Visual Narrowing:** Visual narrowing is a traffic calming technique that uses visual cues and design elements to make the road feel more narrow. Streetmix can be used to test narrowing alternatives within the existing curb or right of way (**Figure 13**).

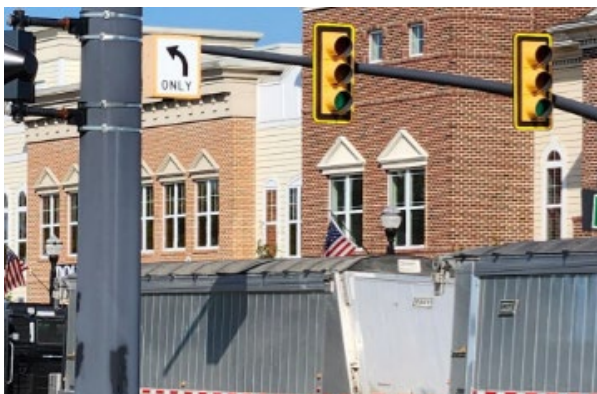
**Figure 15: Signal backplates in downtown Wixom**

There are three signals located within the study area. All signals within the study area have backplates equipped with retroreflective borders. During nighttime field review the RSA team observed limited reflectivity of all signal backplates and some signs within the study area (**Figure 15**).

- **Update signal backplates:** Backplates are added to traffic signal to improve visibility by introducing contrast. The RSA team observed that the backplates retroreflective border was dim and could benefit from replacement.
- **Improve or repaint pavement markings:** Pavement marking updates can be made along Old Wixom Road, and crosswalks can be updated to special emphasis.
- **Increase sign visibility:** Update signs retro reflectivity, and clear branches that may be blocking signs.
- **Install turn guide markings:** Left turns from Wixom Road to Old Wixom Road feel uncomfortable and could benefit from turn guidance markings.

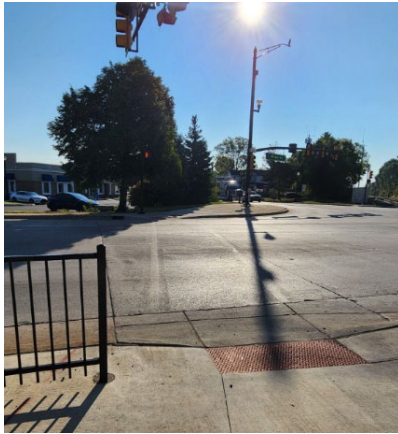
**Figure 16: Faded crosswalk at the Wixom Road and Pontiac Trail intersection**

Additionally, pavement markings throughout the study area are faded or nonexistent in some places. This can especially be seen at crosswalks throughout the study area (**Figure 16**).
