## **The Gibson Farm**

**Prepared by Maura H. Overland and  
Christian W. Overland  
December 16, 1997**

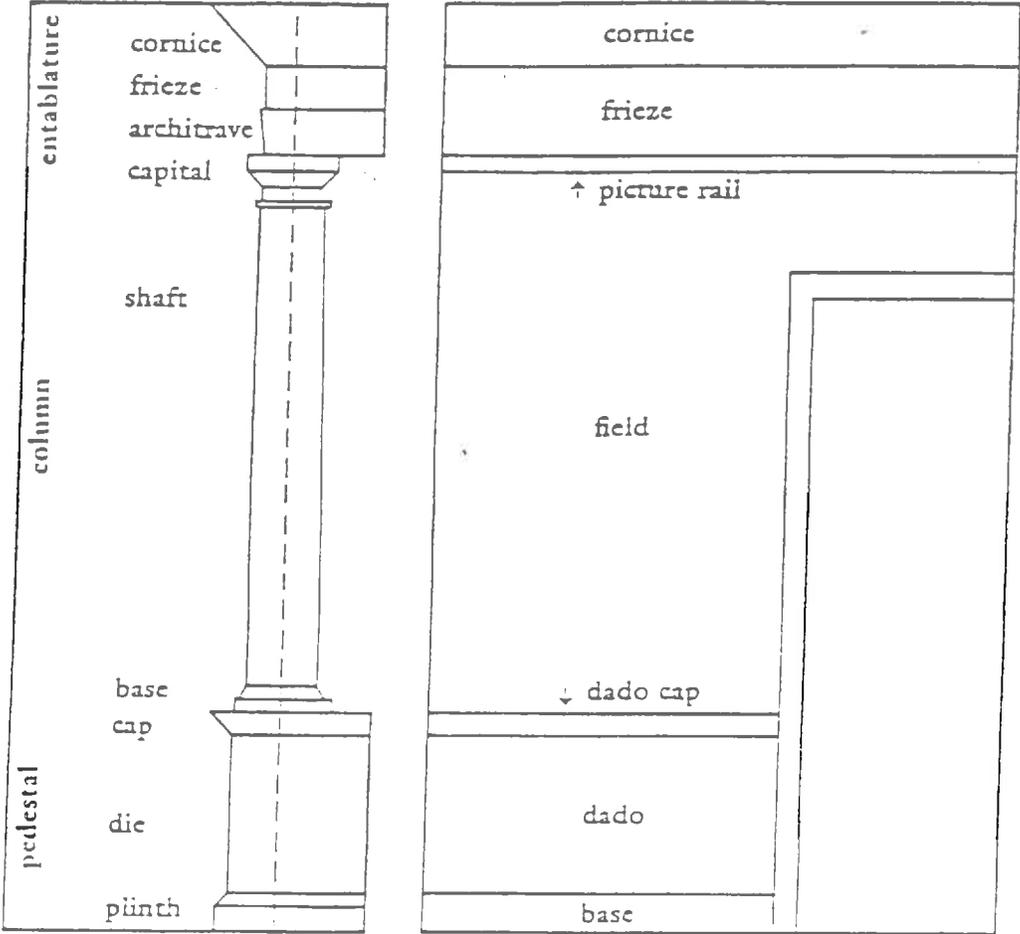
Figure 21 - Corresponding parts of an interior wall and a classical order

A note on moldings in the Gibson House. The interior of the house was designed following the classical Corinthian order (See Figure 21).
